Yeovil Hospital: Hot Work (HW) Incident 22.08.24

An error judgement during the application of a self-adhesive bituminous membrane led to an emergency evacuation of some parts of Yeovil Hospital.

SHE-ALT-2022/YH1

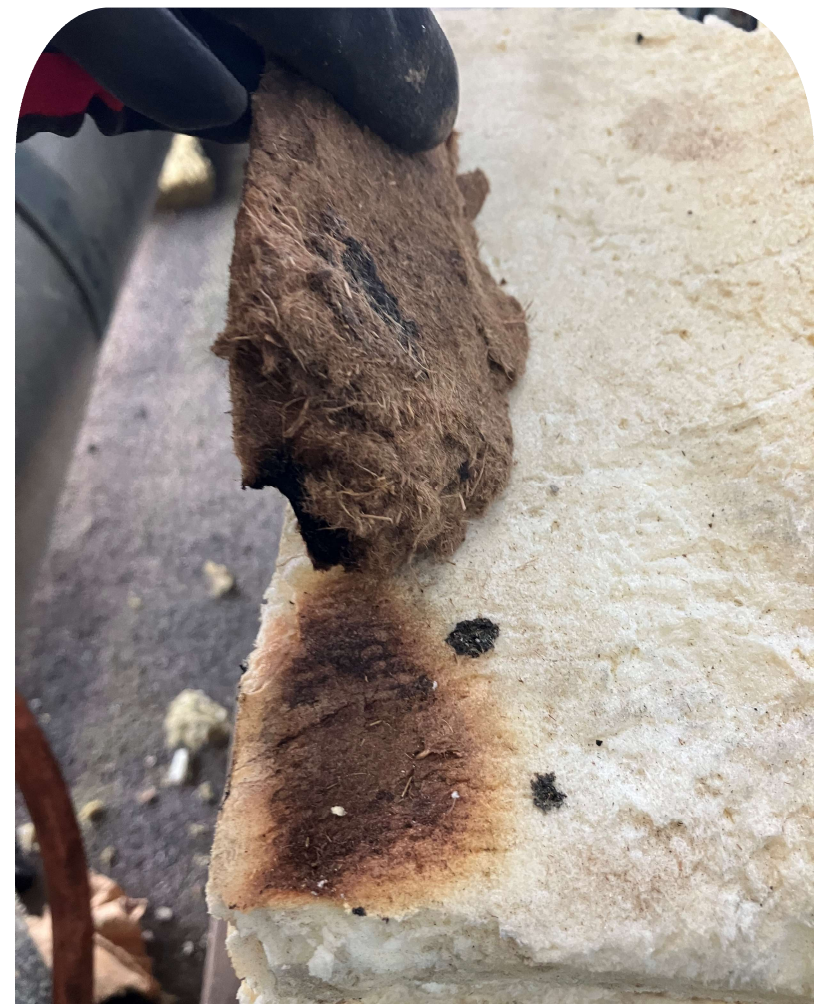
Whilst applying a **self-adhesive** bituminous underlayer, a roofing operative needlessly used an LPG torch to heat the underlayer.

The flame of the LPG torch came into direct contact with an existing fibrous angle fillet causing it to smoulder.

The resulting smell of burning & smoke noticed by hospital staff on the floor below resulted in the evacuation of some parts of the hospital.

- **Immediate Cause:** The use of the LPG torch
- **Underlying Cause:** Custom & Practice: It not uncommon for felt roofing operatives to apply heat to all types of bituminous roofing products in order to achieve a watertight seal.
- **Root Cause:** A failure to specify a completely heat free bituminous roofing product (the capping layer of the specified system required heat applied).

- **Project specific risks** associated with all HW activities are to be identified at pre-construction stage with a view to design out HW wherever possible.
- All operatives undertaking HW to have proof of HW awareness training.
- Thermal Imaging of area to be undertaken before HW commences.
- Requirements for continuous fire watches to be rigorously implemented.
