Excavator Bucket Change Incident

REFERENCE	ISSUED	DISPLAY UNTIL
SHE-ALT-2022/008	JAN 2022	SEPT 2022

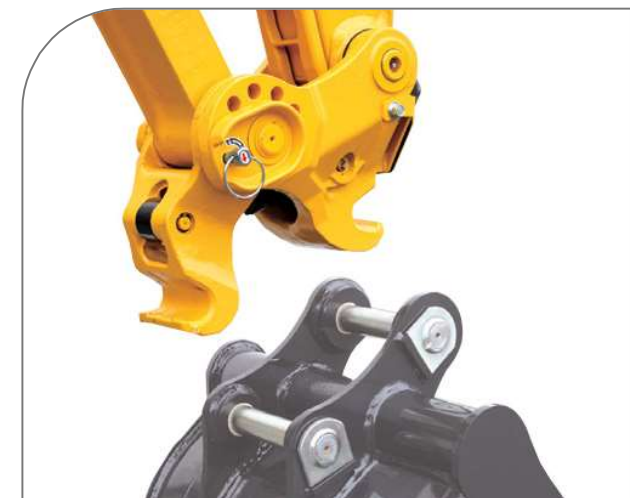
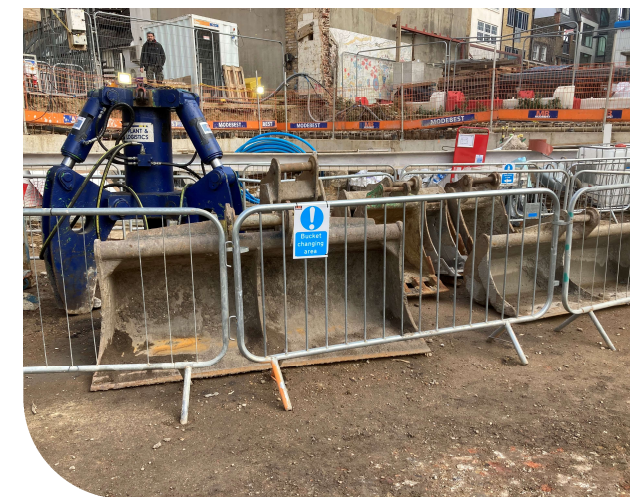
An incident occurred recently on one of our projects where an excavator bucket, that had recently been changed, fell from the quick hitch and rolled down the batter of an excavation striking an operative on the back of the leg. Fortunately he was not injured.

- The excavator was fitted with an audible alarm within the cab that sounds when the quick hitch is not fully engaged. This was defective at the time of the incident. (A functioning alarm is a minimum requirement within the MS Plant Standard)
- The operator had not undertaken shake, rattle and crowding checks following the changing of the bucket.

- The Quick Hitch Pre-Start Check Form (SH9 FRM06) is to be completed for all excavators with quick hitch fitted.
- All excavators must be checked to ensure the quick hitch alarm is in place and operational, and the machine is to be taken out of service where this is not the case.
- Ensure that a dedicated bucket change area is established at each site, and that the operators are instructed not to leave this area until they have physically checked that bucket/attachments are fully engaged.

See Visual Standard **SHE-VIS-052 – Excavator bucket Change Area**
