Dropped objects – Loading Bays

SHE-ALT-2023_14

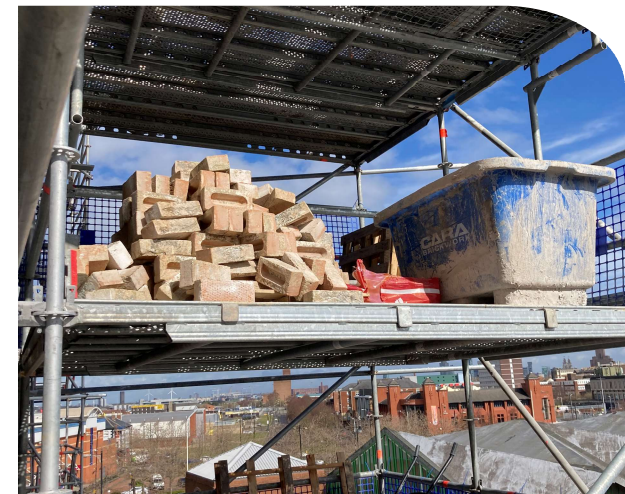
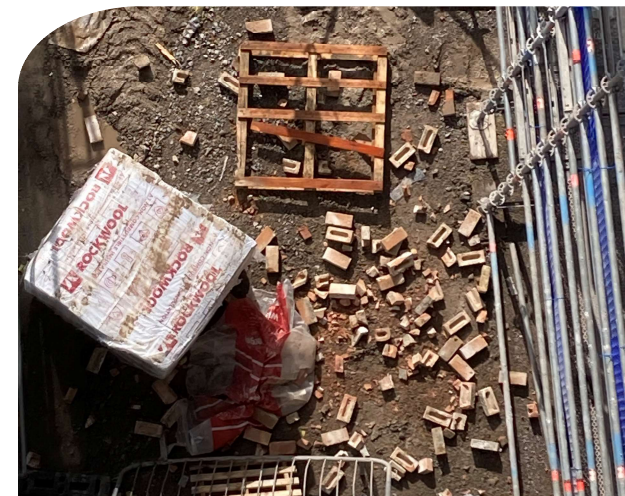
The pallet of bricks had been lifted on to a loading bay using a telehandler, the up and over gate was dropped down and a bricklayer then split the packaging and banding to distribute the bricks across the scaffold level, leaving half a pallet of bricks un-banded on the loading bay.

An empty motor tub was then lifted up to the same level and when the loading bay gate was opened it caught the edge of the pallet of bricks and approx. 30 bricks fell from the loading bay and landed at the foot of the scaffold within the exclusion zone.

- Once the packaging and banding was removed from the brick pallet the loading bay gate shouldn't have been opened until the bricks were removed from the loading bay.
- Materials were positioned close to the loading bay gate hindering its operation and increasing the potential for materials to be knocked off during opening/closing.
- The telehandler was struggling to position the pallet of bricks far enough back on the loading bay due to the height and angle of the lift

- Where materials are positioned on loading bays the gates must not be opened unless all materials are either secured or sufficiently distanced away from the gate
- Loading bay decks should be constructed to allow pump trucks / trolleys etc to transport materials.
- All loading bays **MUST** have exclusion zones in place at their base to prevent person being below if materials should fall.
