## Materials Delivered in Crates

REFERENCE	ISSUED	DISPLAY UNTIL
SHE-BUL-2025_020	MAR 2025	JUNE 2025

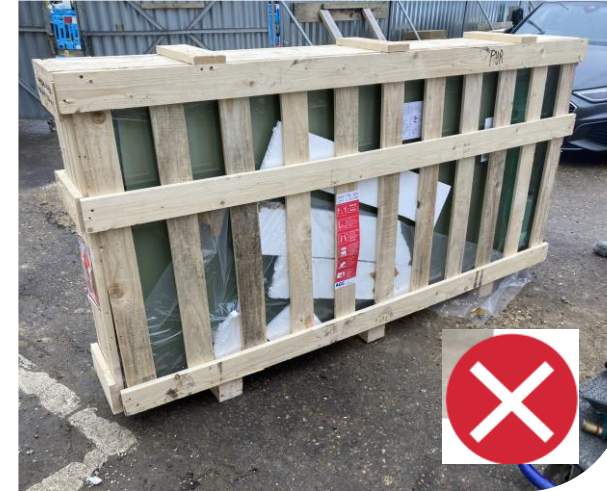
Recently, a delivery of Pyrobel fire glass was delivered to one of our sites in a crate instead of being individually banded on an A-Frame as per our SHE Visual Standards.

Once offloaded, The operatives decided to remove the front panel (in accordance with the crates instructions) and this revealed the glass inside was not secured.

Realising that the glass was unsecured, they attempted to reinstate the crates front panel however whilst doing this the glass became unstable and fell onto an operative trapping their foot between the crate and the ground. Fortunately, no injuries were sustained.

- Ensure all glass providers are made aware of our Visual Standard **SHE-VIS-061 - Glass Storage**, and that any delivery of glass not meeting this standard is refused.
- All sites to check if Pyrobel Glass is specified on a project and contact the supplier to discuss this bulletin and how the glass will be delivered to site.
- Check if other materials/products are scheduled to be delivered to sites in crates. Wherever possible, remove the top panel of the crate first and identify how materials within are secured prior to opening the rest of the crate.
