## Passenger/Goods Hoist Counter weight failure

**Hoist Manufacturer: SAE climber**

**Hoist Model: E20 MK2 (2018)**

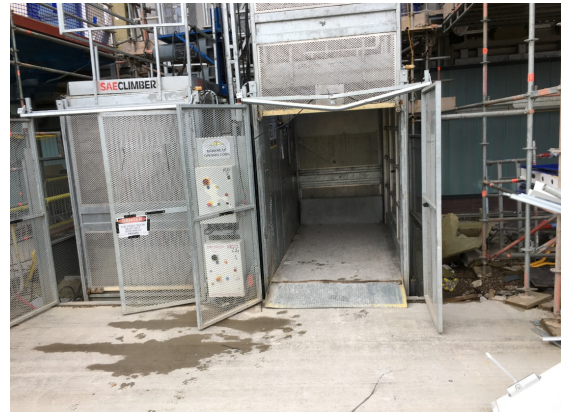
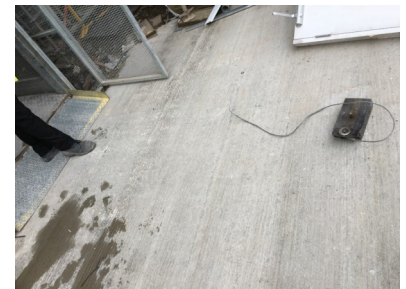
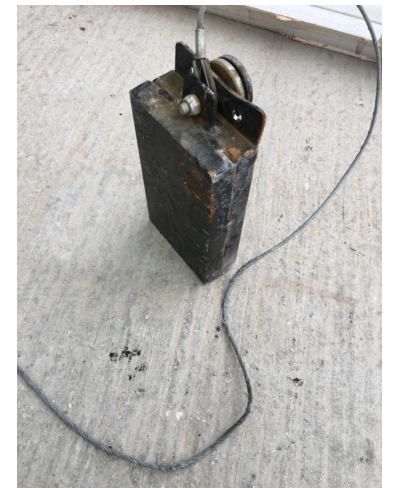
The goods/passenger hoist was travelling down from level 19 to the ground floor when a bang was heard as it passed level 15, the operator of the adjacent hoist observed the 25kg door counterweight detach from the front right-hand side of the hoist and fall to the floor.

The weight struck the latch bar above the right side hoist (Which was at ground floor level) before hitting the ground meters away from a Morgan Sindall Site Manager.

Initial investigation after the incident appears to show damage to the cable that supports the weight in a number of areas that have not been picked up during Daily/weekly inspections

**If this type of Hoist is being used on any of our projects they need taking out of action immediately until further notice and confirmation given to your SHE advisor that this has taken place**

- All SAE climber hoists to be taken out of action
- Inspections of counter weight cables to be completed on all hoists in use
- Counter weight cable inspections to be included on the daily/weekly inspection sheets
- Confirm back to your SHE Advisor once hoists are taken out of action
