Fire – 32 Amp Commando Isolator

REFERENCE	ISSUED	DISPLAY UNTIL
SHE-ALT-2025_27	DEC 2025	FEB 2026

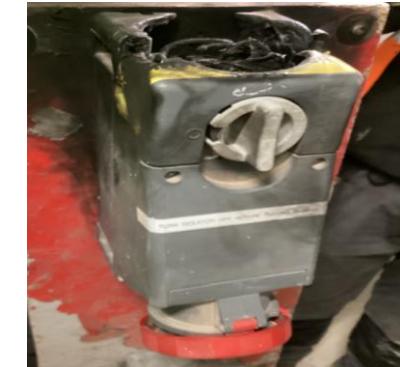
A 32 Amp Commando Isolator, that was supplying power to a blow heater, caught alight during operation of the heater. Fortunately, the fire was immediately extinguished, limiting the damage to the isolator only.

- Commando Isolators/sockets are not portable electrical equipment, and must always be secured in place, either directly to the structure, or to a frame that is secured in place.
- Adequately plan the location and number of commando sockets required to ensure they are located near to equipment. This will remove the need for them to be portable.
- Ensure fire risk assessments are regularly updated, and that newly installed items such as heaters and electrical equipment are considered, particularly their duration of use.

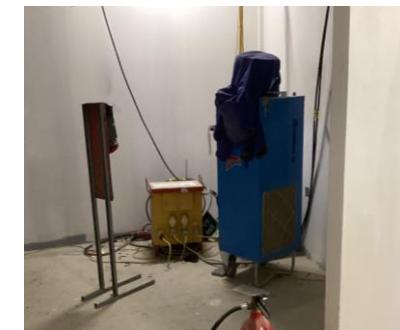
A loose connection within the commando socket. This caused arcing and overheating that ultimately resulted in the fire.
