Trip & Fall Accident - Trip Hazards and Mobile Phone Use

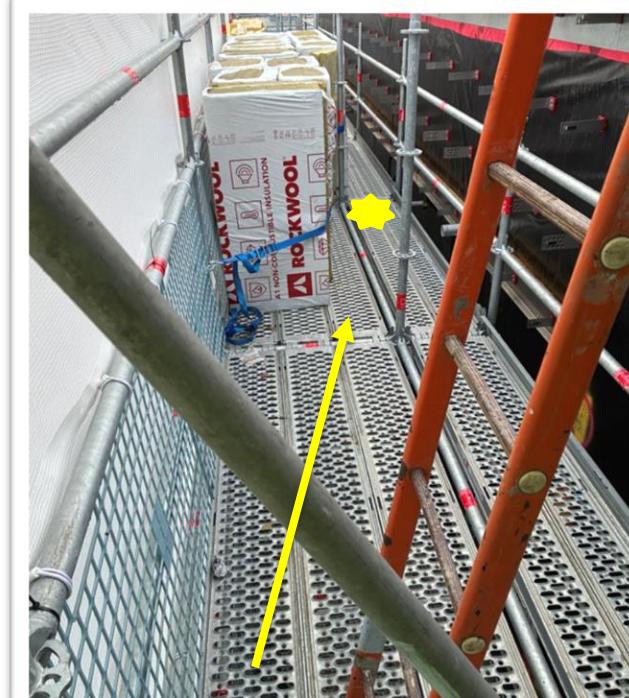
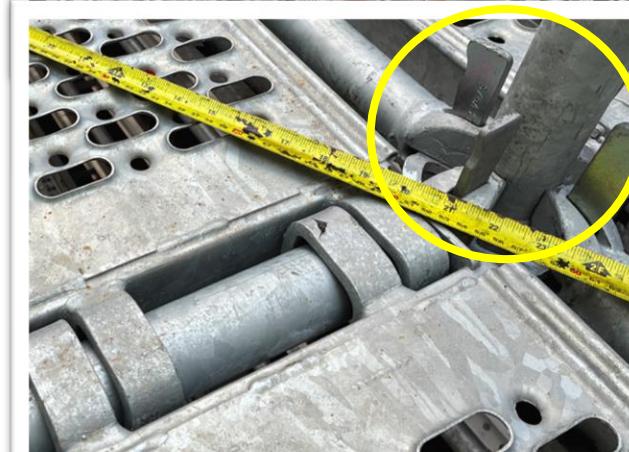
An Injured Person (IP) was walking along a scaffold deck and stepped through a 500mm gap between stored insulation materials and a scaffold standard. The scaffold deck is affixed with a "wedge head fitting" on this Plettac Metrix proprietary system scaffold with this component protruding 60mm above the deck around the standards. The IP tripped over the wedge head, fell forwards on to the same level, and sustained a fractured bone in their right hand and a hairline fracture to their right knee – RIDDOR reportable injuries.

- The IP was walking along the scaffold looking at work related photographs on their mobile phone when they tripped and therefore not paying full attention to underfoot conditions.
- Access along the scaffold had been reduced to a 500mm gap at the point of the accident due to stored insulation and the location of the scaffold standard.
- The wedge head fitting is a standard Plettac Metrix scaffold component and creates an inherent trip hazard albeit this would ordinarily be viewed as a negligible risk in most instances.

- Communicate this alert to all site users reminding all persons to use mobile phones and other mobile devices sensibly, standing still in a safe place.
- Aim to maintain at least 600mm wide access routes along scaffolds to reduce risks of slips or trips, in accordance with HSE guidelines.
- Reduce the volume of materials, equipment, tools etc. stored on scaffold decks where possible, limiting to shorter-term storage for only what is required for the task at hand, and avoid longer-term storage for future works in these locations.
- When planning work and procuring scaffolds, consider the design and type of scaffolds including the width of scaffold decks, and suitability for the work to be undertaken including material storage requirements and movement of people.
